## EXPERIMENTAL INVESTIGATIONS ON DETERIORATION OF HISTORIC BRICKS FROM SELECTED MUGHAL MONUMENTS OF KHYBER PAKHTUNKHWA, PAKISTAN

### ABSTRACT

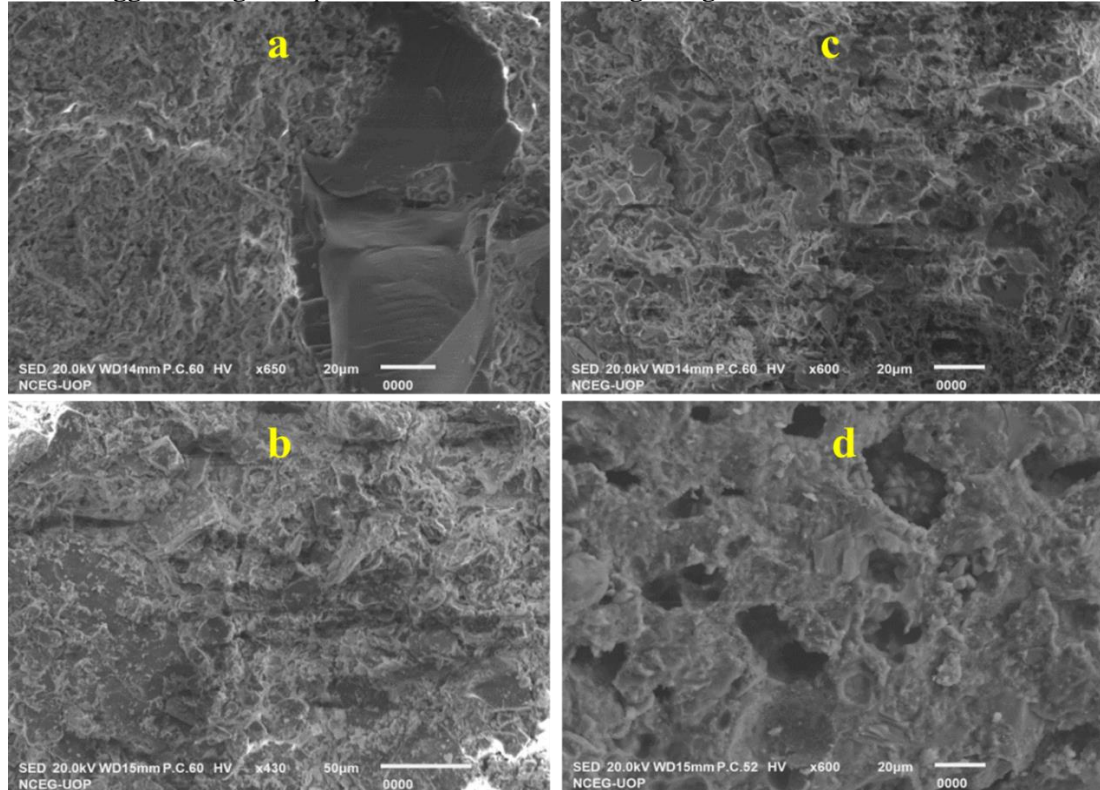
Figure 1: displays the images of bricks samples collected site from Khyber Pakhtunkhwa province of Pakistan. (a) SEM micrograph of Dilazak Tomb (east) named DT-02. (b) SEM micrograph of from Gor Khatri complex (west) named GK-01. (c) SEM micrograph of Mahabat Khan Mosque (North) named MMK-01. (d) SEM micrograph of Guli Bagh (South) named GB-01.

The microstructure of bricks was analysed by Scanning Electron Microscope (SEM). Figure 1 displays the SEM images of bricks samples collected site from Khyber Pakhtunkhwa province of Pakistan. (a) SEM micrograph of Dilazak Tomb (east) named DT-02. The image reveals that bricks used in Dilazak Tomb showed macropores due to deterioration, (b) SEM micrograph of from Gor Khatri Archaeological complex (west) named GK-01. Micrograph reveals that some

scaling appears on the surface of the bricks due to incrustations, (c) SEM micrograph of Mahabat Khan Mosque (North) named MMK-01. Like above some deposits are shown on the surface of brick sample while (d) SEM micrograph of Guli Bagh (South) named GB-01 displays larger voids and scaling on the brick surface. Raw minerals displayed various states of decomposition depending on the dimension of the grains in the groundmass, which was highly dense (sintered) and reactive. Reaction rims were frequently present, where new silicates were formed. Carbonate relicts were also present, although the high degree of textural evolution which suggested high temperature was reached during firing.

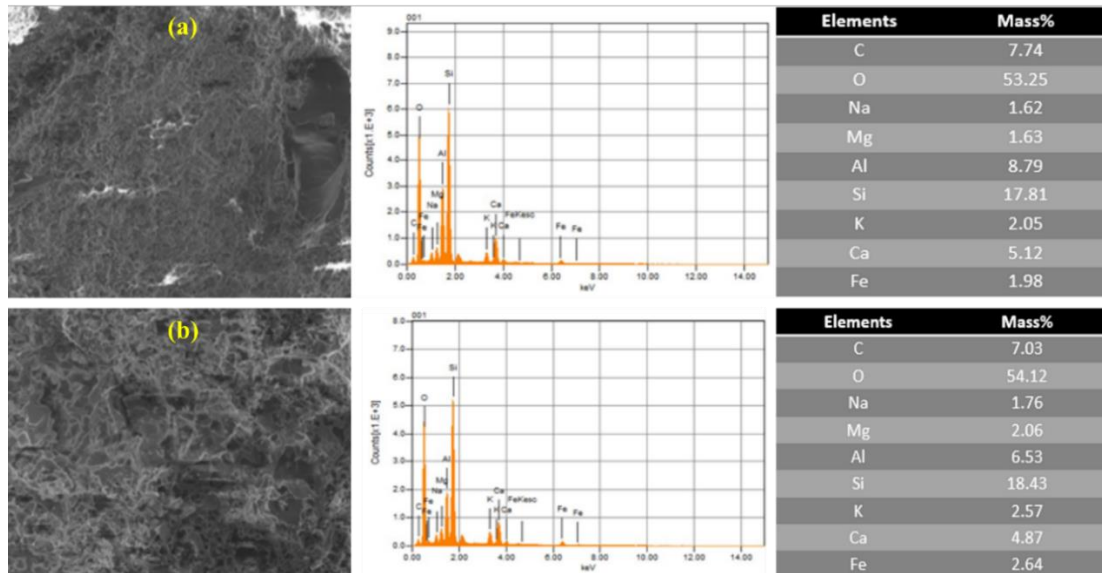
Figure 2: shows the EDX analysis of the brick's samples taken from Khyber Pakhtunkhwa province of Pakistan. (a) EDX analysis of sample taken from Dilazak Tomb (east) named DT-02. (b) EDX analysis of sample taken from Gor Khatri Archeological complex (west) named GK-01

To understand the textural and mineralogical changes, EDS analysis of bricks was conducted by spot analysis at various locations. Figure 2 shows the EDX analysis of the brick's samples taken from Khyber Pakhtunkhwa province of Pakistan. (a) EDX analysis of sample taken from Dilazak Tomb (east) named DT-02. Chemical composition of bricks taken from Dilazak Tomb showed 17.81% Si which reveals that clay used to make these bricks contains higher amounts of silicon. Al, Ca, K and C were also in considerable quantities, oxygen being the highest in quantity up to 53.25%. While in (b) EDX analysis of sample taken from Gor Khatri Archaeological complex (west) named GK-01. These bricks of Gor Khatri Archaeological complex contain mineral salts like Si, Ca, Mg, Fe along with C were higher than Dilazak Tomb. Presence of mineral salts in the brick samples including silica, Alumina, Iron etc. has been verified by SEM analysis. Moreover, during the firing of clays containing carbonate grains (calcareous clays) produces carbonates and calcite as a result of lime carbonation “lumps” produced

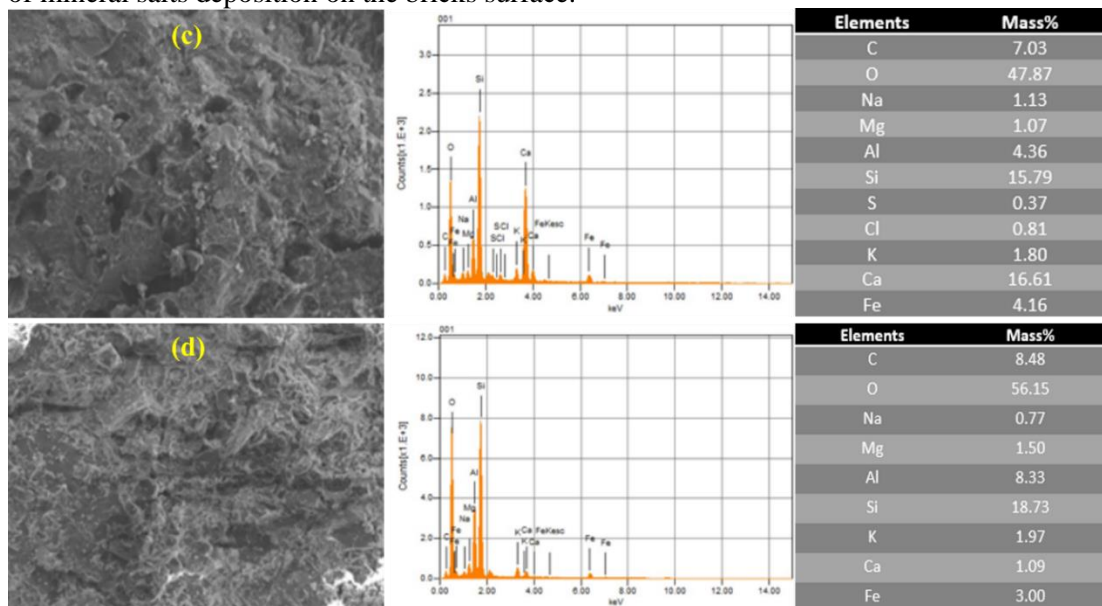
Figure 3: (c) EDX analysis of sample taken from Mahabat Khan Mosque (North) named MMK-01. (d) EDX analysis of sample taken from Guli Bagh (South) named GB-01.

Figure 3 (c) also show the EDX analysis of the brick's samples taken from Khyber Pakhtunkhwa province of Pakistan. (c) EDX analysis of sample taken from Mahabat Khan Mosque (North) named MMK-01. These bricks samples contain 7% C, up to 48% O, up to 16% Si, while Ca is up to 17% with 4.16% Fe contents. While (d) EDX analysis of sample taken from Guli Bagh (South) named BG-01. Similarly mineral salts with somehow same quantity are present in bricks samples taken from Guli Bagh. According to analysis it can be concluded that all the bricks were synthesized from the clay containing mineral salts like Si, Ca, Fe, K, C and Al in considerable amounts. SEM micrographs of these samples also wetted the presence of mineral salts deposition on the bricks surface.

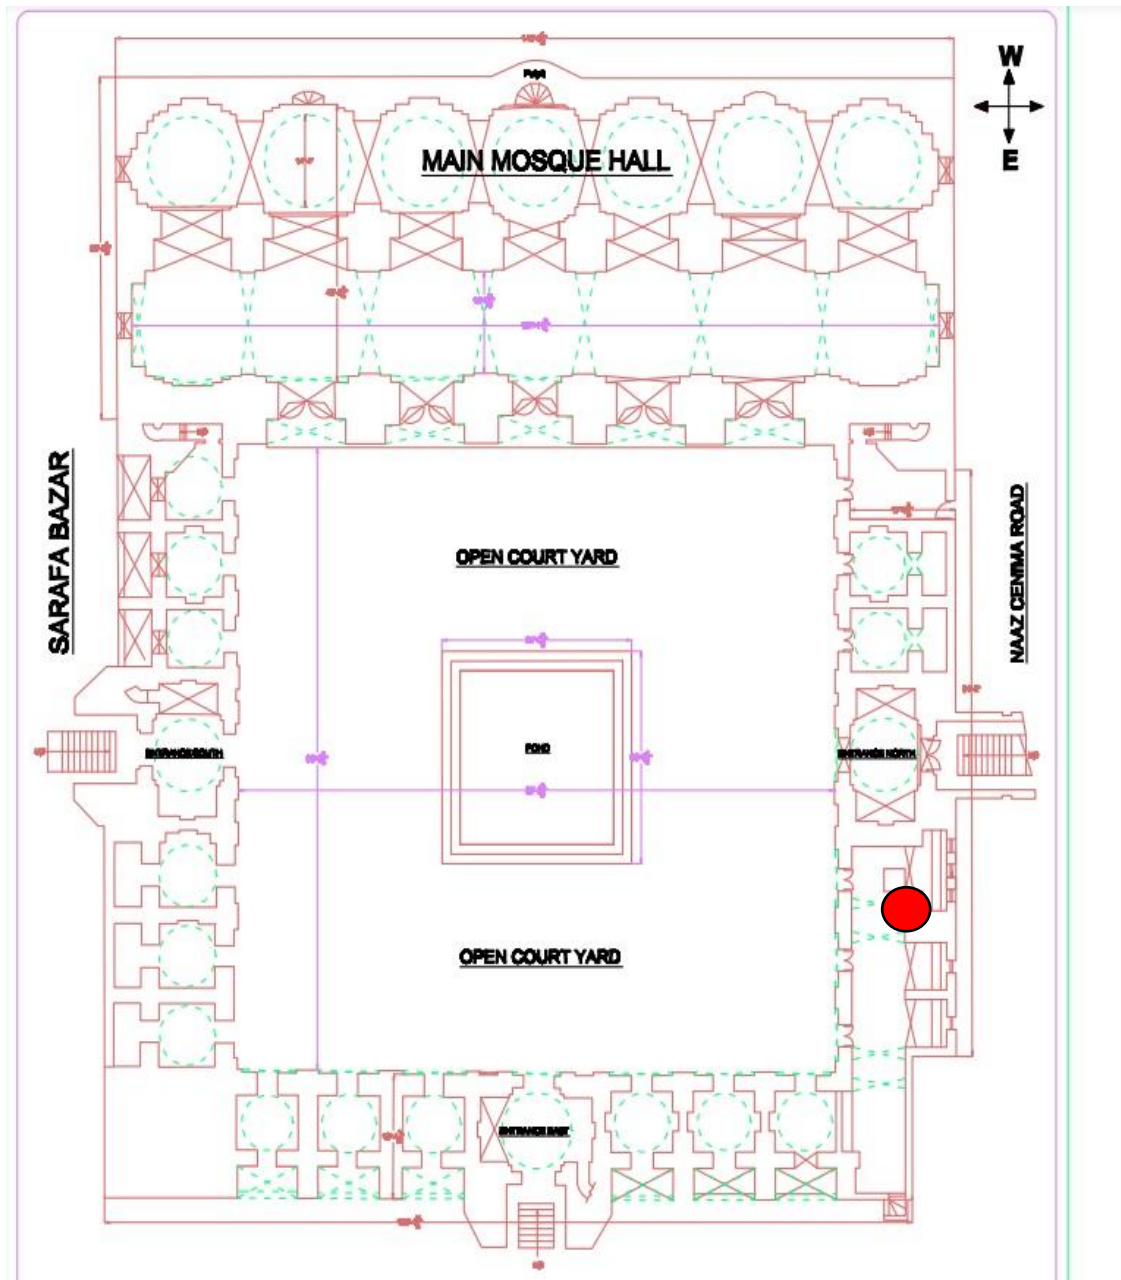
Figure.a: Mahabat Khan Mosque, Peshawar: Layout Plan and sampling area (encircled) (After DOAM KP, 2022)

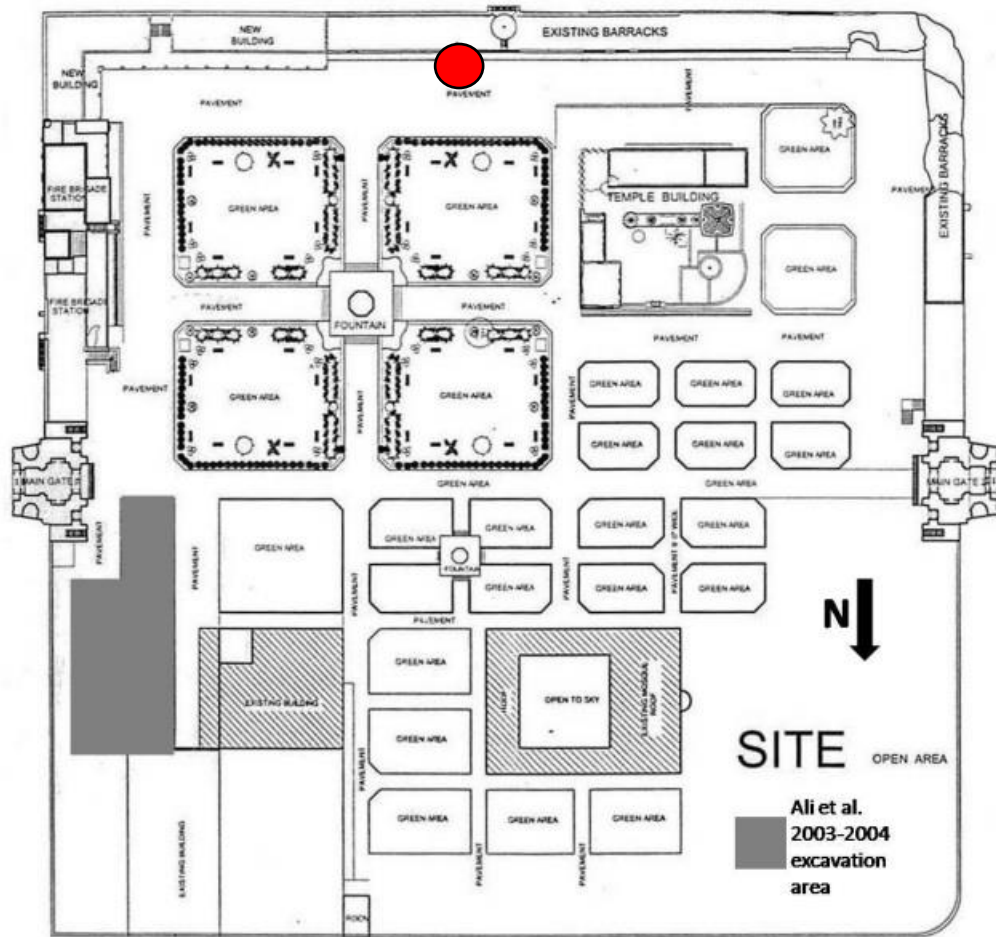
Figure.b: Gor Khatri Complex, Peshawar: Layout Plan and sampling area (encircled) (After Ali et al. 2005:271)

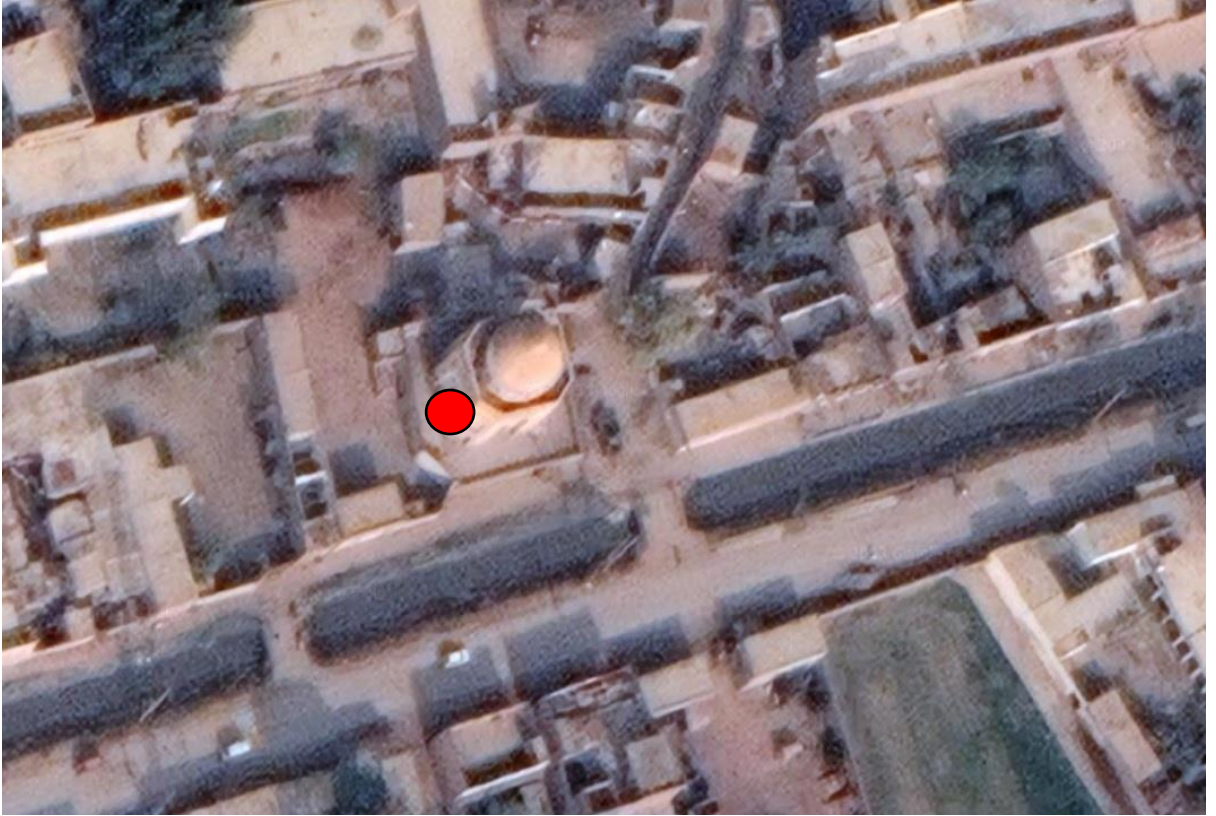
Figure.c: Dilazak Tomb, Peshawar: Layout Plan and sampling area (encircled) (After Google Maps, 2023)

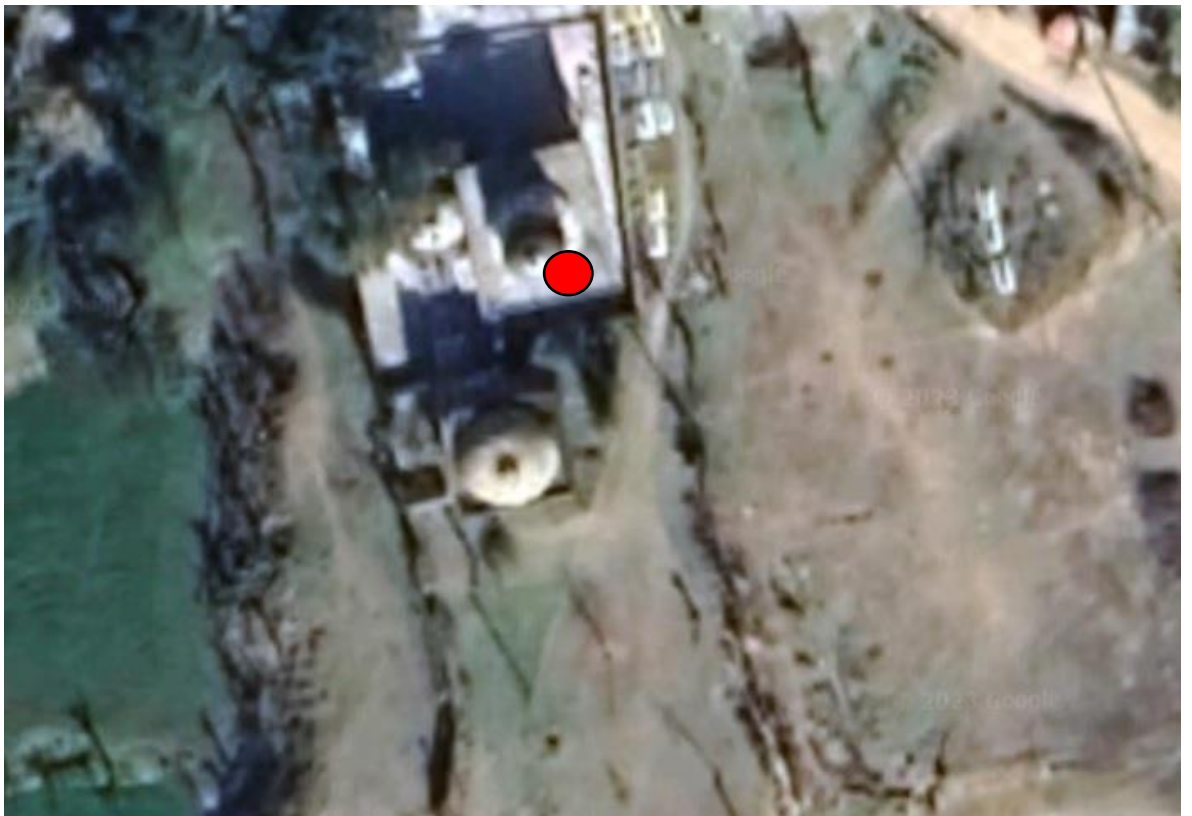
Figure d: Guli Bagh, Mansehra: Layout Plan and sampling area (encircled) (After Google Maps, 2023)
